# **CASE STUDY OF THE CAUSES OF FAILURE OF COMBINATION OF GABION AND GEOTEXTILE CONSTRUCTION TO HANDLE LANDSLIDES ON THE SLOPE OF KARIANGAU SUBSTATION, BALIKPAPAN, EAST BORNEO**

Desy Rahmadania dan Rusdiansyah

*Civil Engineering Department, Faculty of Engineering, University of Lambung Mangkurat*

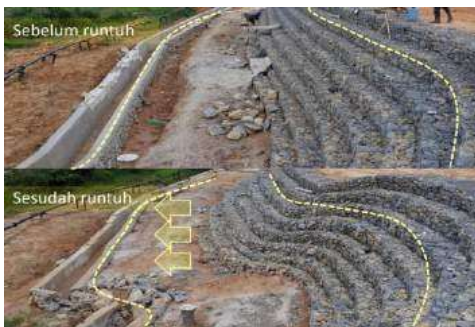
In this case, the slopes of the GI Kariangau-Balikpapan, East Kalimantan are reviewed, which uses a combination of gabion construction and geotextiles as an effort to increase slope stability. However, when excavation activities were carried out at the foot of the slope, failures in the gabion and geotextile construction were seen as shown in Figure 1.1.

Figure 1.1 Deformation of Shapes in Gabion Construction.

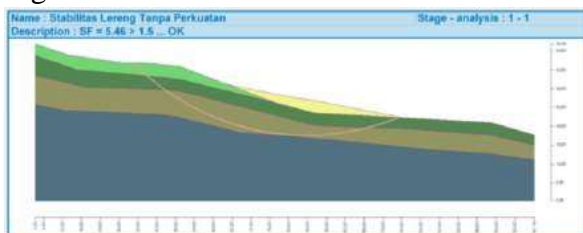
Figure 4.6 Results of Slope Stability Analysis Before Reinforcement

Based on Figure 4.6, the slope safety factor value is  $5.46 > 1.5$  which indicates the slope can be said to be safe against landslides.

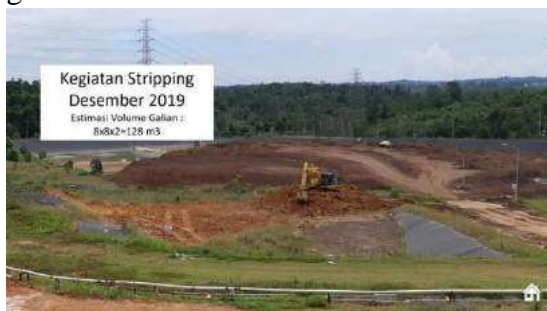
There are excavation activities at the foot of the slope as shown in Figure 4.9 with an estimated excavation dimension of 8m x 8m x 2m. This excavation was carried out after the slope was reinforced with gabions and geotextiles with an estimated distance of excavation to level 1 reinforcement of gabions of 50-80 m.

Figure 4. 9 Excavation Activities at the Foot of the Slope.

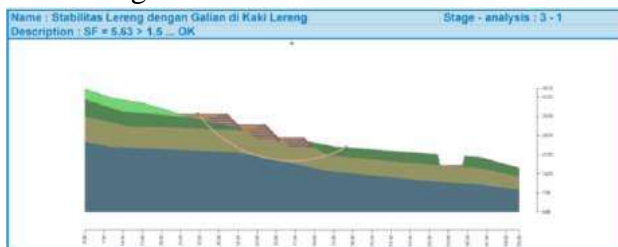
Figure 4. 10 Results of Slope Stability Analysis with Excavations at the Foot of the Slope

Based on Figure 4.10, the slope safety factor value is  $5.63 > 1.5$  indicating the slope is safe against landslides. However, when compared to the slope without excavation, this value decreased from 5.76 to 5.63 after excavation at the foot of the slope. This shows that excavation activities at the foot of

the slope affect the value of the slope safety factor against landslides. However, the decline that occurs in this condition the slope can still be said to be safe from landslides.

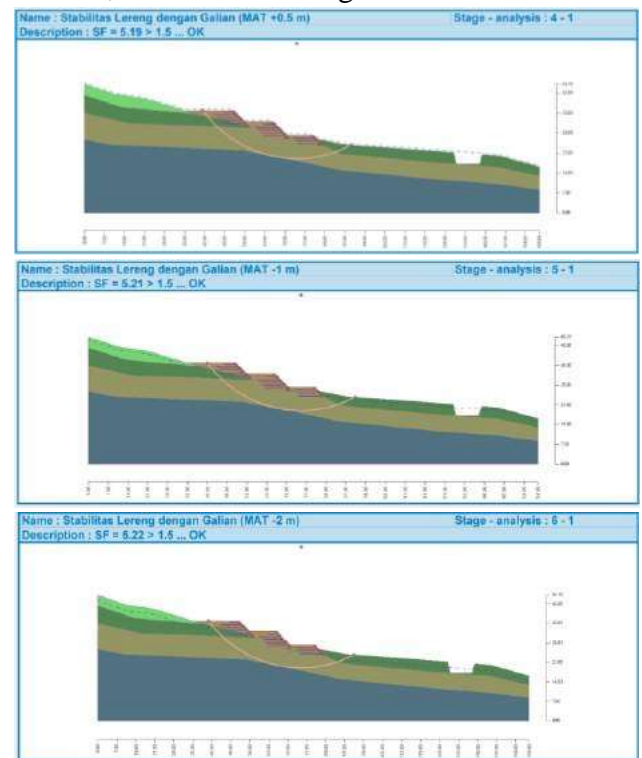
Figure 4. 11 Results of Slope Stability Analysis with Advance Groundwater +0,5 m, -1m, and -2 m

From these results, it can be said that the rain conditions modeled with variations in the groundwater level affect reducing the value of the slope safety factor which was originally 5.63 down to 5.19 when heavy rains are modeled with a groundwater level of 0.5 above the surface. However, the decrease in the safety factor that occurs still meets the minimum value of the slope safety factor of 1.5 so that the slope is still said to be safe from landslides.

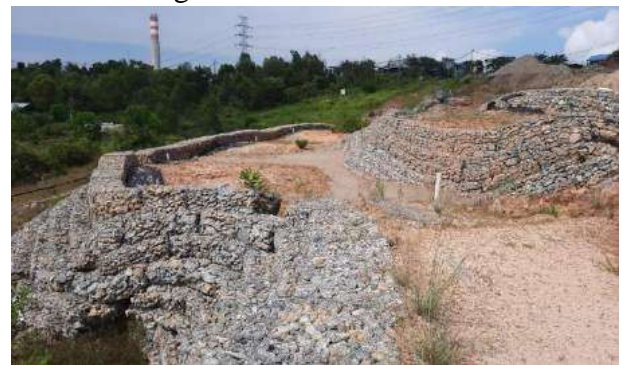
Figure 4.12 Deformation of Gabion Construction Form

Damages that occurred to the reinforcement of gabions and geotextiles was caused by landslides due to soil movement. In addition, when observing conditions in the field, it was also found that there were natural pipe holes formed due to the flow of water coming out of the soil as in Figure 4.14 and there was a flow of water that came out due to being trapped in the embankment soil as in Figure 4.15.

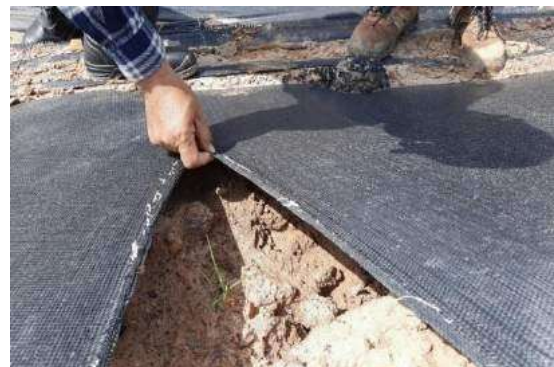
Figure 4.13 The Damage of Geotextile Joints

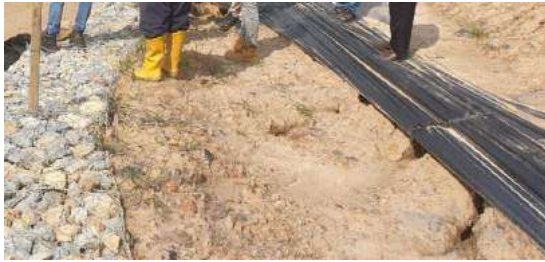
Figure 4. 14 Formation of a Natural Piping Hole Due to Water Flows from the Ground

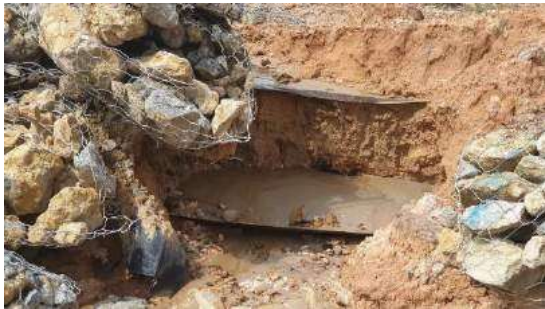
Figure 4. 15 Source of Water that Comes Out of Stockpiled Soil

This condition is certainly different from the results of the initial data interpretation, where the groundwater level is found to be quite deep with a range of 3 m below the surface. Therefore, it is necessary to review the results of the geoelectric survey to determine the condition of underground water flow on the slopes.

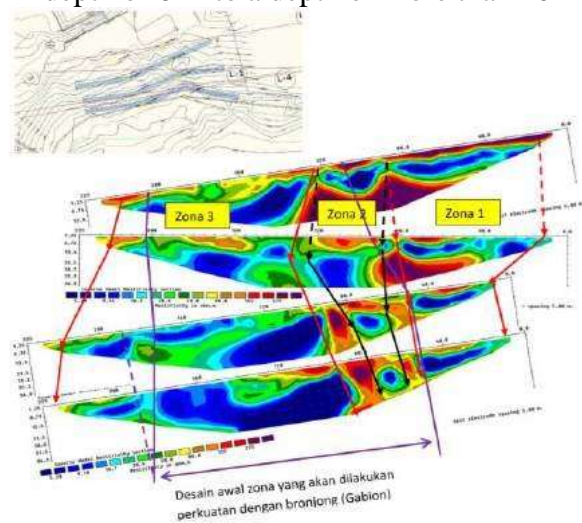
In zones 1 and 2 the water flows from north to south which was originally at a depth of 6 m to a depth of more than 10 m.

Figure 4.17 Direction of Water Flow

While in zone 3 the water flow from north to south which was originally at a depth of 6 m on track 3 until it comes to the surface on tracks 2, 1, and 4. In zone 3 there are also seepage points/bottom water sources land.

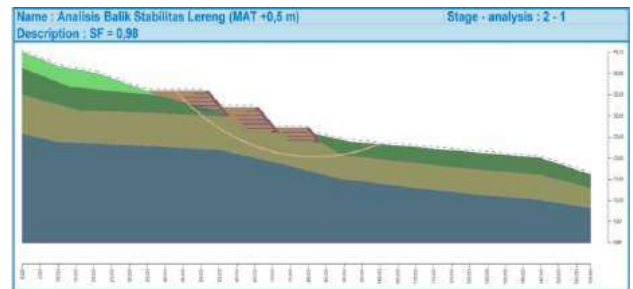
Figure 4. 18 Results of Reverse Analysis of Slope Stability with MAT +0.5 m

Based on the figure above, the slope safety factor value is  $0.98 < 1,07$ . Referring to Bowles (1991), this value indicates that the slope is sliding. This is in accordance with the conditions in the field where there is ground movement or landslides occur on the slopes. So that the value of the soil parameters that make up the slopes from the back analysis in Table 4.8 can be said to be close to the soil conditions in the field.

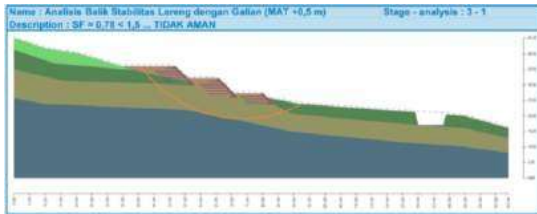
Figure 4.19 Value of Slope Safety Factor with Excavation and MAT +0.5 m.

Based on the picture above, the slope safety factor value is 0.78, which value does not meet the safety requirements for the slope safety factor of 1.5. It can be said that the slope is experiencing a landslide.

So it can be said that due to the movement of underground water flow that flows to the surface based on geoelectric results in the area of gabion and geotextile reinforcement, as well as heavy rains in the rainy season, the soil becomes saturated with water. This causes a decrease in the value of the soil parameter, thereby reducing the value of the slope stability factor of safety against landslides.
