## ANALYSIS OF THE HABITABILITY OF PELAMBUAN RESIDENTIAL AREA, WEST BANJARMASIN

Erika Zeannyta \*, Aqli Mursadin

Faculty of Engineering, Lambung Mangkurat University Banjarmasin, South Borneo, Indonesia,  
[erika.zeannyta@gmail.com](mailto:erika.zeannyta@gmail.com), [a.mursadin@ulm.ac.id](mailto:a.mursadin@ulm.ac.id)

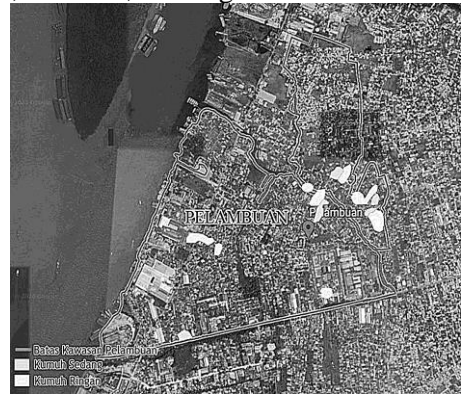
Figure 1. Map of Pelambuan residential area, West Banjarmasin (Identification of Slums in the 2015 Mayor's Decree)

area not being fully utilized by investors due to a lack of promotion and information about the potency area. Figure 1 shows the Pelambuan area with distribution locations slum settlements with Low criteria, Medium, and High.

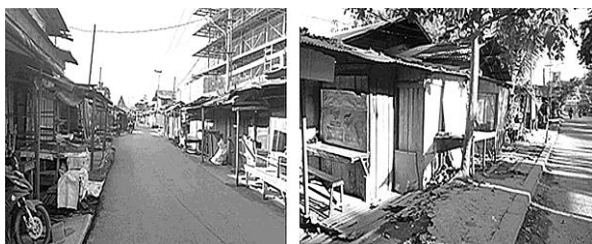
Figure 2. Settlements in Pelambuan (Personal documentation)

These problems are the background behind analyzing the habitability of both the building and the residential environment. This case does for know the condition of residential buildings and the environment in terms of feasibility and quality. Pelambuan residential area will be analyzed based on three physical aspects: building, environmental, and legality. Building aspects review construction used, the physical condition of the building, lighting in buildings, indoor ventilation buildings, and building health includes the spatial condition of the intended building to analyze the habitability of the building housing in settlements in the Village ambush. Build quality housing formed affects the environment surrounding settlements, where the quality bad residential buildings affect the appearance of the settlement environment formed. The view of residential buildings seen on environmental display can be seen in Figure 2.
