ANALYSIS OF THE HABITABILITY OF PELAMBUAN RESIDENTIAL AREA, WEST BANJARMASIN

Erika Zeannya *, Aqli Mursadin

Faculty of Engineering, Lambung Mangkurat University Banjarmasin, South Borneo, Indonesia,
erika.zeannya@gmail.com, a.mursadin@ulm.ac.id

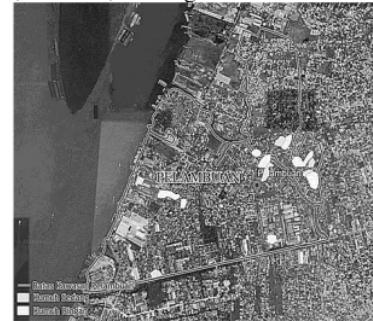
area not being fully utilized by investors due to a lack of promotion and information about the potency area. Figure 1 shows the Pelambuan area with distribution locations slum settlements with Low criteria, Medium, and High.

Figure 1. Map of Pelambuan residential area, West Banjarmasin
(Identification of Slums in the 2015 Mayor's Decree)

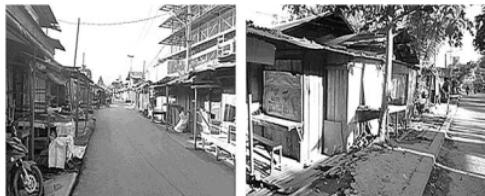
Figure 2. Settlements in Pelambuan (Personal documentation)

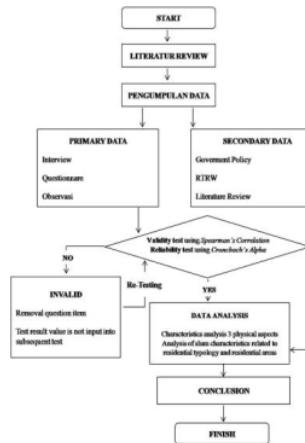
All research activities will be described in Figure 3, which is a flow chart research.

Figure 3. Flowchart research (Personal analysis, 2020)
