## Analysis Of Water Status Quality And Flood And Inundation Causes In Rawa Matang Hanau Irrigation Area Balangan District

**Abstract:** Matang Hanau is an irrigated swamp area located in Lampihong District, Balangan Regency this will be developed into a swamp irrigation area. The area is inhabited by transmigratory community with oil palm gardening as their livelihood. The plantation products obtained were unsatisfactory because the land was often flooded due to flooding that often occurs during the rainy season. The transmigratory community is also challenged with the clean water problem for their daily needs. The community must fulfill their need for drinking water by buying from outside the transmigratory area. Whereas bathing and washing, they use water in the existing channel of the swamp irrigation. On channels where people use the water, there are cages of chicken and cattle farms, so that the water used by the community has been polluted by the waste of chicken and cattle farms. Along with the use of water in these channels, health problems such as sickness arise.

Chandra Wahyu Sulistyo "Analysis Of Water Status Quality And Flood And Innundation Causes In Rawa Matang Han

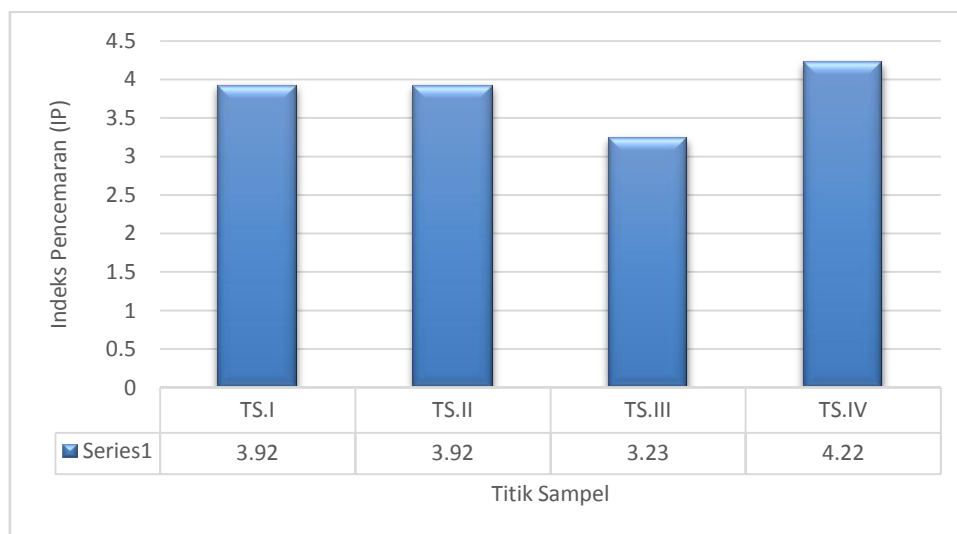
**Figure 1. Results of Pollution Index Analysis on Quality Standards I**

The analysis indicates that all IP values for all sample points against quality standards are in the range of  $1.0 < PI_j \leq 5.0$  which identifies that the water condition in the channel is lightly polluted against the quality standard I as the designation of raw water clean water.

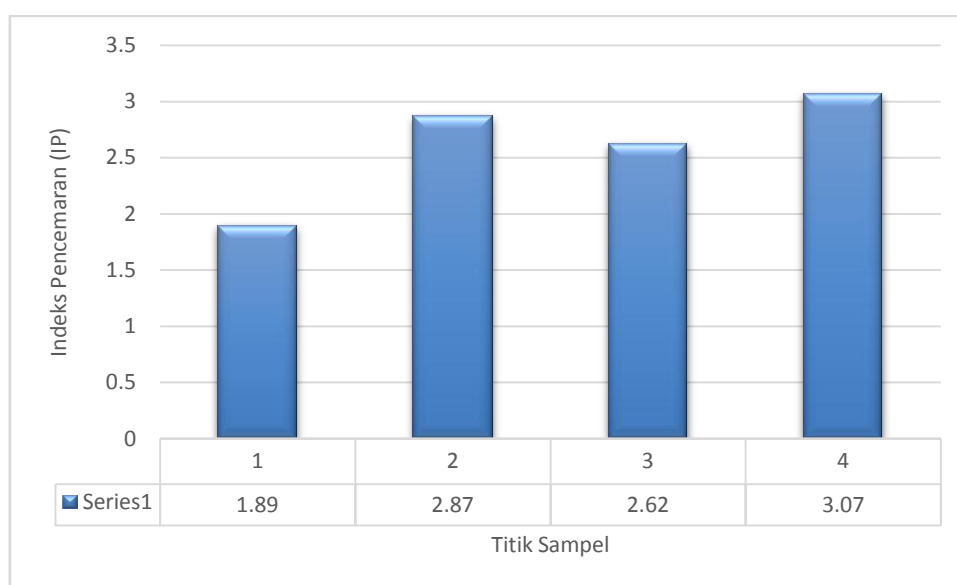
**Figure 2. Results of Pollution Index Analysis on Quality Standards II**

The analysis indicates that all IP values for all sample points against the quality standard are in the range of  $1.0 < PI_j \leq 5.0$  which identifies that the condition of the water in the channel is lightly polluted against the quality standard II as water designated for agricultural and plantation purposes.

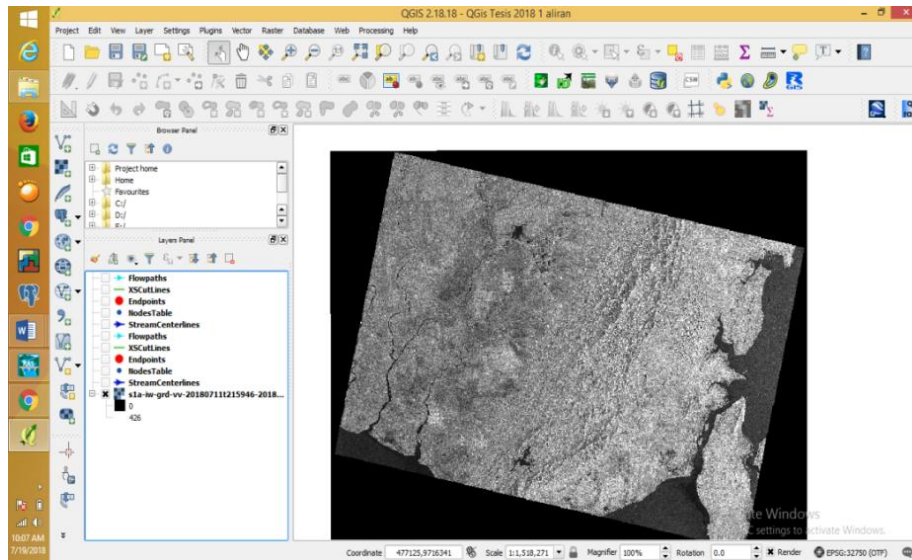
**Figure1. DEM Layer (Source: Analysis)**

Evaluation of the existing channel begins with the imitation of channel geometry using the Qgis 2.18.18 application and using model elevation data (DEM) obtained from <https://scihub.copernicus.eu>. Imitation of channel geometry in gis application is supported by rivergis application. The results of geometry imitation can be seen in Figures 3 and 4.

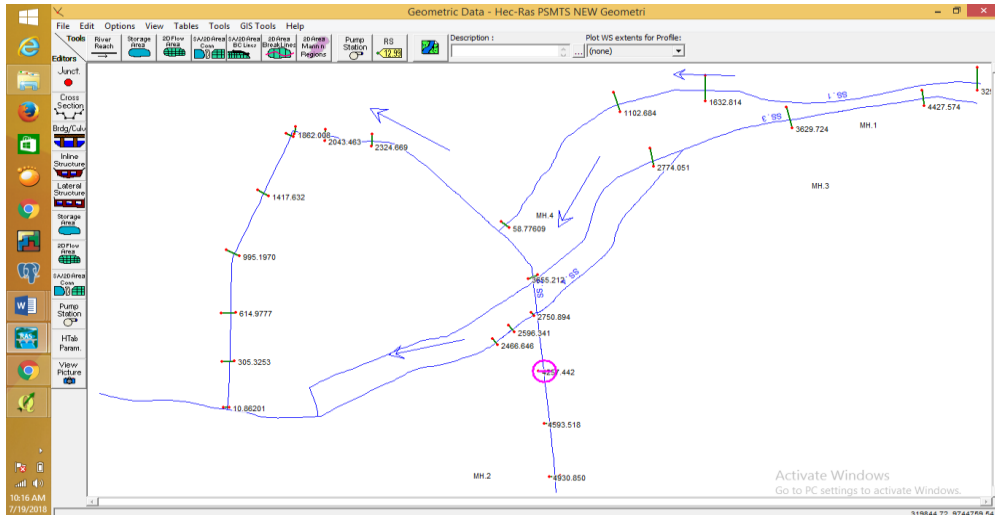
Figure 5. Channel Geometry Results Imported from Qgis (Source: Analysis)

After the channel geometry imitation is complete, the channel geometry is converted to a hec-race file using the RiverGis plugin. The geometry of the converted channel is imported into hec-race as the channel geometry for the hydraulic analysis process, as shown in figure 4.6.

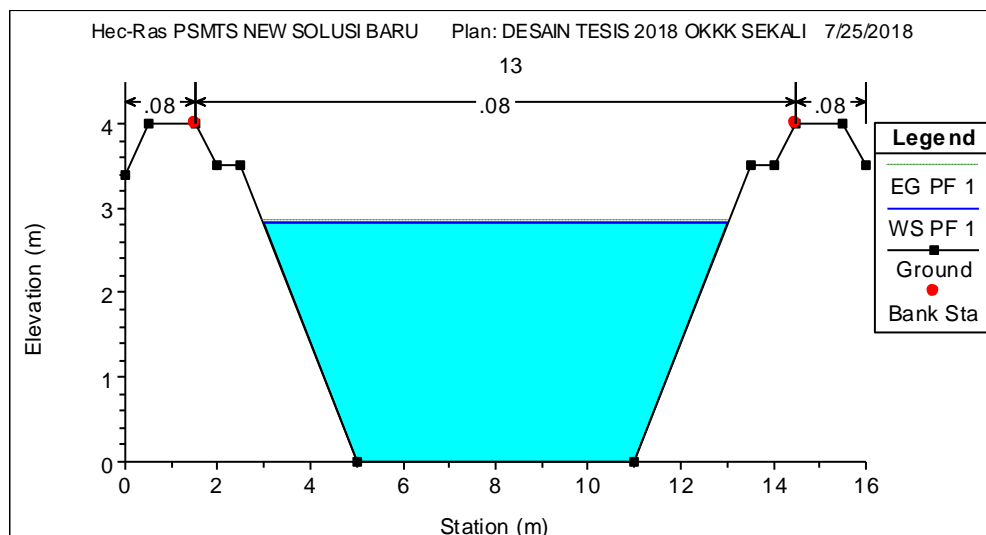
Figure 7. Cross Section Simulation P.1 SS.1-MH.1 (Source: Analysis)

Based on the design calculation, the channel dimension can accommodate the flood debit plan. Based on the data - design data of channel dimensions and flood debit plan, the simulation was taken with Hec-race application. Simulation results can be seen in the following figure:
