CASE STUDY OF THE CAUSES OF FAILURE OF COMBINATION OF GABION AND GEOTEXTILE CONSTRUCTION TO HANDLE LANDSLIDES ON THE SLOPE OF KARIANGAU SUBSTATION, BALIKPAPAN, EAST BORNEO

Desy Rahmadania dan Rusdiansyah
Civil Engineering Department, Faculty of Engineering, University of Lambung Mangkurat
E-mail: desyrahmadania12@gmail.com

ABSTRACT

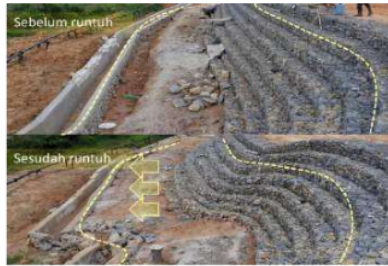
Figure 1.1 Deformation of Shapes in Gabion Construction.

In this case, the slopes of the GI Kariangau-Balikpapan, East Kalimantan are reviewed, which uses a combination of gabion construction and geotextiles as an effort to increase slope stability. However, when excavation activities were carried out at the foot of the slope, failures in the gabion and geotextile construction were seen as shown in Figure 1.1.

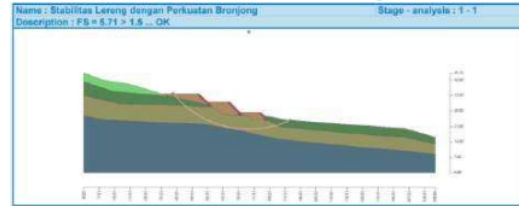
Figure 4.7 Results of Slope Stability Analysis with Gabion Reinforcement.

After obtaining the value of the safety factor on the slope without reinforcement, then an analysis is carried out on the slope with only the reinforcement of gabions. This is done to determine the effect of gabion reinforcement on the slope safety factor in landslides, which can be seen in Figure 4.7.

Based on Figure 4.6 and the image above, the following results are obtained:

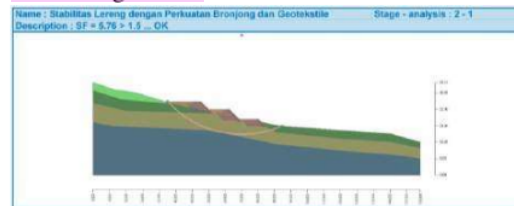
Figure 4.8 Results of Slope Stability Analysis with Geotextile Reinforcement.

Next, an analysis of the slopes with additional geotextile reinforcement was carried out as in field conditions. This is done to determine the role of geotextiles on the value of the slope safety factor, which can be seen in Figure 4.8.

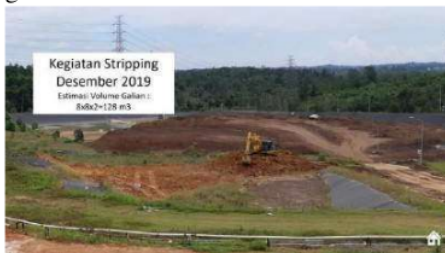
Figure 4. 9 Excavation Activities at the Foot of the Slope.

There are excavation activities at the foot of the slope as shown in Figure 4.9 with an estimated excavation dimension of 8m x 8m x 2m. This excavation was carried out after the slope was reinforced with gabions and geotextiles with an estimated distance of excavation to level 1 reinforcement of gabions of 50-80 m.

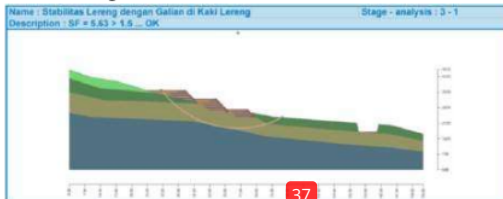
Figure 4. 10 Results of Slope Stability Analysis with Excavations at the Foot of the Slope

It is necessary to make a model on the program to determine the effect of the excavation on the value of the slope safety factor. The value of the safety factor can be seen in Figure 4.10.

Based on Figure 4.10, the slope safety factor value is $5.63 > 1.5$ indicating the slope is safe against landslides. However, when compared to the slope without excavation, this value decreased from 5.76 to 5.63 after excavation at the foot of the slope. This shows that excavation activities at the foot of

the slope affect the value of the slope safety factor against landslides. However, the decline that occurs in this condition the slope can still be said to be safe from landslides.

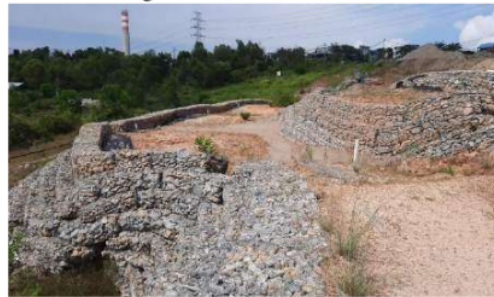
Figure 4.12 Deformation of Gabion Construction Form

After analyzing the stability of the slopes, it was found that the slopes were safe from. This of course does not explain the cause of failure in the construction of a combination of gabion reinforcement and geotextiles. Therefore, it is necessary to review the condition of the slopes in the field after a landslide occurs. Some of the damage that occurred in the reinforcement construction of gabions and geotextiles can be seen in Figures 4.12 and 4.13.

Damages that occurred to the reinforcement of gabions and geotextiles was caused by landslides due to soil movement. In addition, when observing conditions in the field, it was also found that there were natural pipe holes formed due to the flow of water coming out of the soil as in Figure 4.14 and there was a flow of water that came out due to being trapped in the embankment soil as in Figure 4.15.

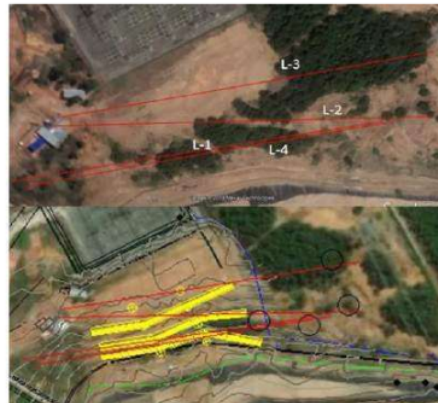
Figure 4. 16 Geoelectrical Trajectory Plan

This geoelectric measurement was carried out by PT. Bangun Prima Semesta with 2-dimensional measurements. It should be noted that this measurement is carried out during the rainy season, with the advantage of being able to clearly see the difference between zones that are saturated with water and those that are not. The location of data collection used as many as 4 paths, can be seen in Figure 4.16. With point 0 for each

track starting from the east side and the distance between the electrodes is 5 m.
