Restoration of Peat Dome in Ex-Mega Rice Project Area in Central Kalimantan

Novitasari Novitasari^{1, a)}, Joko Sujono¹, Sri Harto¹, Azwar Maas² and Rachmad Jayadi¹

¹Department of Civil and Environmental Engineering, Faculty of Engineering, Universitas Gadjah Mada, Indonesia

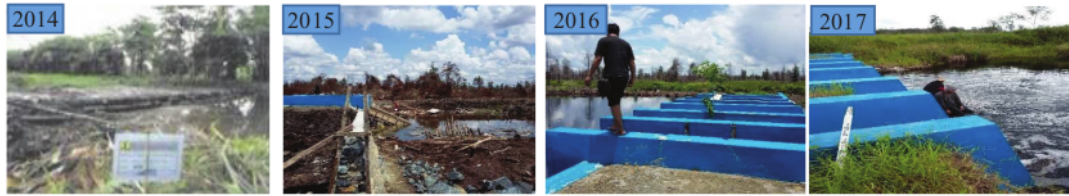
FIGURE 2. (a) Compacted canal blocking in canal D, [15], (b) redesign canal blocking in 2015, (c) canal blocking in 2016 and (d) canal blocking in 2017

The design and construction of canal blocking made by *Balai Wilayah Sungai* (BWS) Kalimantan II, Banjarmasin in collaboration with *Balai Rawa-Puslitbang SDA*. In canal D, blocking design by compacted peat dam

was built in 2014. At 2015, it was redesigned with concrete block. Observation for this present study took 3 years since November 2015 – August 2017. It is showed in Figure 2. In canal E, canal blocking made by concrete material was built in 2014 showed in Figure 3. Figure 4 shows condition in canal C without blocking.

Canal blocking is equipped by flow of boats in the middle that is adjusted to the conditions in the area. This plot is provided so that small boats (local people called *ces*) can pass through the canal blocking so as not to interfere with their daily activities. Boat streamline is made high enough, equal to the block streamline to prevent water from passing as shown in Figure 2 and 3.

In canal blocking D, the restoration process on peatland ecosystem condition is not seen clearly like in canal E. It is caused by the redesigning of new block material. Ecological condition in upstream canal D gradually returns to its original condition of peatland that inundated in rainy season 2017.

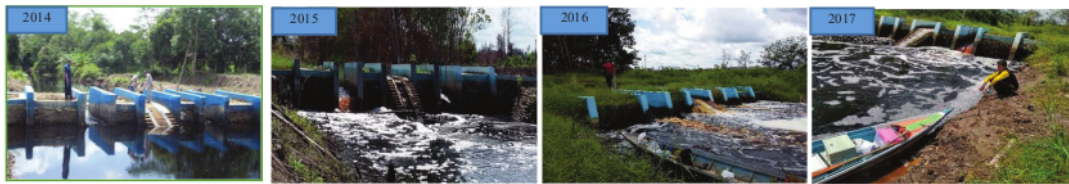
FIGURE 3. (a) Concrete canal blocking in canal E in 2014 [15], (b), (c), (d) canal blocking condition in 2015 to 2017

The observation was conducted for three years from November 2015 after the end of a long drought and the occurrence of El Nino phenomenon that caused wildfires in tropical peatland in Indonesia. For 3 years, there was a considerable change in peatland ecosystems around and upstream E canal blocking. Ecological condition gradually returns to its original condition of peatland that inundated in rainy season 2017. Upstream canal begins to be covered by fallen trees into the canal. The restoration process in canal E gives good results.

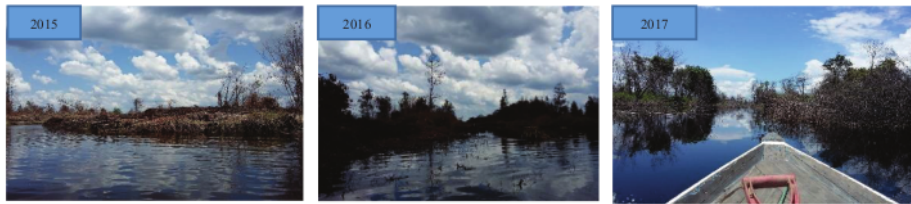
FIGURE 4. Canal C condition without blocking in 2015 – 2017

Ecosystem conditions in canal C from observation year 2015 to 2017 do not show any difference without restoration process. It is shown in Figure 4.
