# THE SLOPE STABILITY OF WATER CANAL AND LANDSLIDE MANAGEMENT AT DADAHUP WATER CANAL CONSTRUCTION IN CENTRAL KALIMANTAN

**Cite this Article:** Rusdiansyah, Riza Fahlefi, Arif Dhiaksa, Akhmad Fadqur Rahman and Hari Nugraha Nurjaman, The Slope Stability of Water Canal and Landslide Management at Dadahup Water Canal Construction in Central Kalimantan, Journal of Civil Engineering and Technology (JCIET). 9(1), 2023. pp. 1-12.

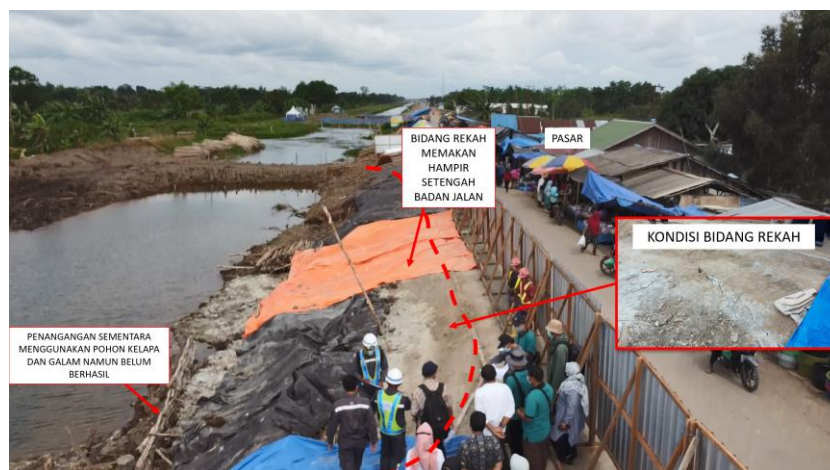
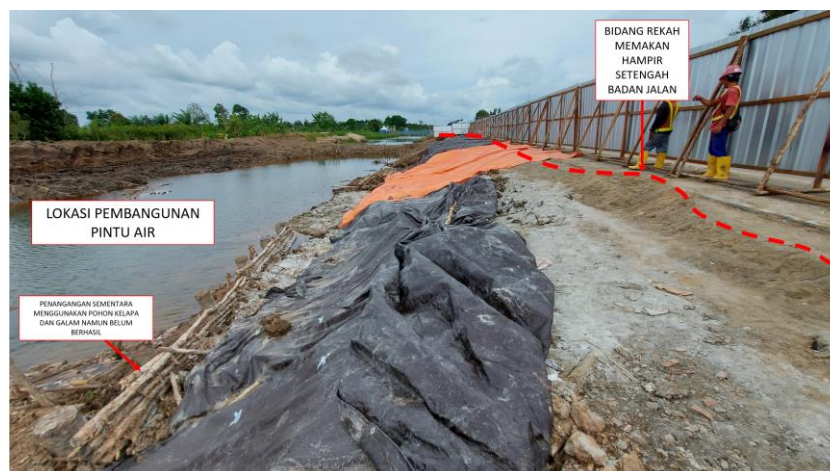
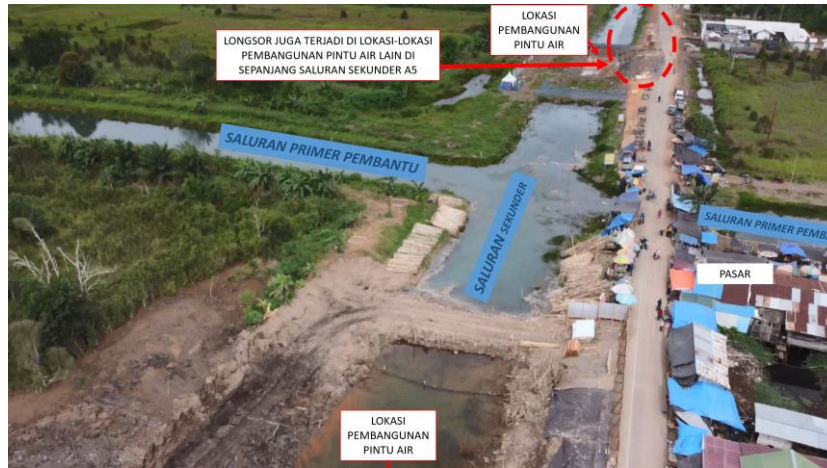
**Figure 1** The Landslide Site

At the onset of the water gate construction, a slope failure occurred along the traffic access road adjacent to Bina Jaya Village. Figure 1(1,b,c) visualizes the current condition of the landslide area. Figure 2 illustrates the design of sluice building to be constructed in close proximity to the landslide site.

The landslide management at the site vary, including the installation of sheet piles, installation of soldier piles, reinforcement with mini pilales, installation of geotextile walls, sloping slopes, and others. As seen from the consideration of considerations, in this study the handling of landslides is by using plaster or sheet pile. The type of sheet pile chosen is type GU 18-400 steel material with the following specifications:

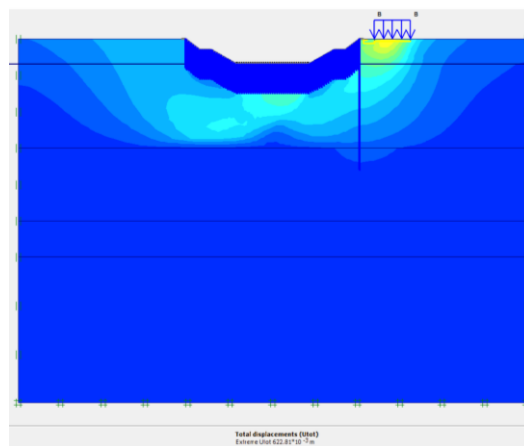
**Figure 6.** The Output Sheet pile walls are specifically designed to resist lateral (horizontal) soil pressure that occurs when there is a change in soil height that exceeds the internal shear angle.

Figure 6 displays the outcome of the Plaxis modeling for slope stability analysis utilizing sheet pile reinforcement with a length of  $L=18$  meters. By providing sheet pile reinforcement with a length of  $L=18$  meters to the slopes at the study site, the safety factor for slope stability would increase to  $SF=2.1 > 1.0$ . This indicates that the slope's stability with sheet pile reinforcement ( $L=18m$ ) is secure, averting the risk of slope failure.

The increase in the safety factor for slope stability after being reinforced with a long sheet pile of  $L=18m$  indicates that the sheet pile construction generates a greater opposing force than the thrust that displaces the slope. A sheet pile length of  $L=18m$  satisfies the requirement to intercept the slope failure circle that may occur. Figure 6 displays a different deformation pattern from those in Figures 7 and 8. The deformation pattern in Figure 7 appears more sloping, and the critical slump circle has been intercepted by an appropriate sheet pile length.

The thick soft clay deposit is one of the factors that trigger canal avalanche in Dadahup Irrigation System in Central Kalimantan Province. This soft clay has small shear strength and it slides easily if there is a trigger. Slope reinforcement using sheet pile with a stake length of 18 meters was determined as the effective method in the landslide management at this site. The sheet pile reinforcement has been able to increase the value of the safety factor for slope stability which exceeds the minimum requirements for the safety factor based on the SNI 8460 of 2017.
