Analysis of Environmental Vulnerability Using Satellite Imagery and Geographic Information System in Coal Mining Area Planning at Banjar Regency

To cite this article: Nurlina et al 2020 IOP Conf. Ser.: Earth Environ. Sci. 499 012014

### Analysis of Environmental Vulnerability Using Satellite Imagery and Geographic Information System in Coal Mining Area Planning at Banjar Regency

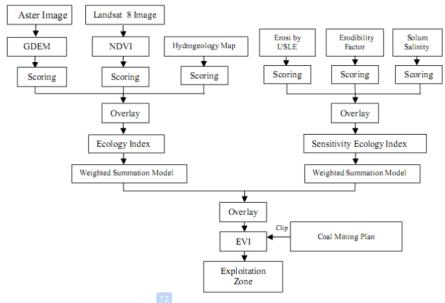
Figure 1: Research flow chart.

This research consists of the preparation stage, namely primary and secondary data collection, data processing consisting of making DEM slope, NDVI transformation, erosion prediction processing using formula USLE (Universal Soil Loss Equation) by taking into account several factors, namely rain permittivity, factors soil vulnerability, length and slope factors, vegetation cover and plant management factors, special soil conservation factors. Scoring on each indicator using the AHP method and the value of the scores were tested for consistency, overlay slope index data, vegetation greenness index and hydrogeological index in order to obtain an ecological index, overlay was data also performed on the erosion index, soil erodibility index, soil salinity index so that the ecological sensitivity index was obtained. The weighting of the ecological index and the ecological sensitivity index uses the AHP method. Ecological index and ecological sensitivity index in the overlay obtained Environmental Vulnerability Index (EVI) which can be used in the data analysis stage using the grid system on the geo statistical method.

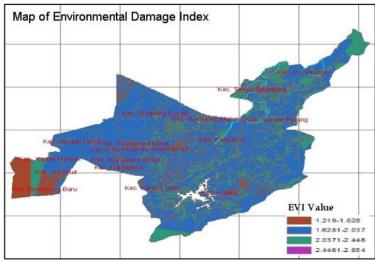
Figure 3. Map of environmental damage index in Banjar Regency.

The superposition of the layout of coal mining planning and overlaying the ecological index with an ecological sensitivity index obtained the EVI (Ecological Vulnerability Index) with the lowest value of 1.219 and the highest value of 2.854. The results of the vulnerability index can be plotted against the area into four zones, namely suggested exploitation zones, exploitation zones optimized, exploitation zones need supervision, zones should not be exploited. Map of environmental damage vulnerability can be seen in figure 3.
