INNOVATION OF SUBSTITUTE MATERIAL TO CONSERVATION EFFORT OF *Eusideroxylon zwageri* ON WOODEN BRIDGE MAINTENANCE PROJECT

Ita Minarni¹, Henry Wardhana², Aqli Mursadin³, Mufidah Asyari⁴

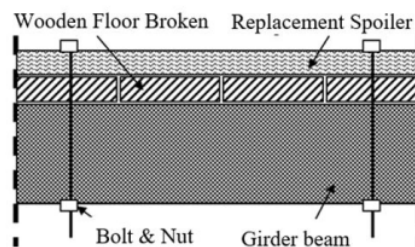
Figure 2. Innovative Design of Floordeck and Reinforced Concrete Installation

The replacement of ulin wooden by floordeck in concrete work is planned both in the preparation and execution process so that the casting is completed faster, very efficient in terms of installation. Using a steel floordeck to replace ulin wooden bridge floor can save cement, formwork, and scaffolding by up to 25–30% in material usage (Clouston & Schreyer, 2008; Johnson, 2018). The construction design of the previous condition is shown in Figure 1, and design of the improvement innovation using a floordeck is as shown in Figure 2.

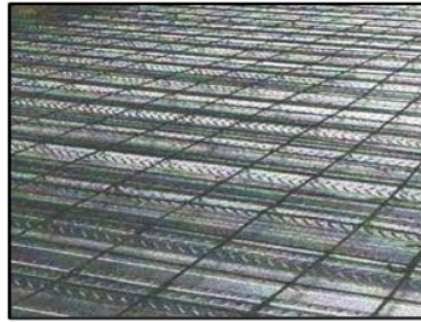
Figure 3. Installation of Reinforced Steel Composite and Floordeck

The Budget plan is prepared based on the calculation data of the volume of work obtained, the results of the calculation of the budget plan for the implementation of innovation work with a bridge size of 4 x 29.4 m is cost of IDR 200,000,000 (two hundred million rupiah) or USD 13,350 including all costs. Some part of the implementation of innovation by floor deck as shown in Figure 3. (Dias et al., 2016; Sahab et al., 2005).

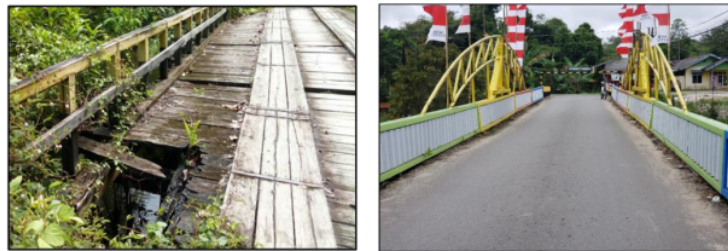
Figure 4. Bridge Condition Before and After Maintenance by Innovation

Planning and implementation analysis of the Tampa Bridge maintenance project was carried out based on the data obtained during the previous maintenance implementation. At the time of planning the maintenance of the bridge, there has been a change from the main material of ulin wooden bridge being replaced with a composite material of concrete and floordeck. The ulin wooden bridge, which had been broken for some time, could not be repaired (PUPR Buntok, 2018). In the end, the improvements could be made with the innovation of using floordeck composite materials and reinforced concrete then the Tampa Bridge can be used by the surrounding community as shown in Figure 4.

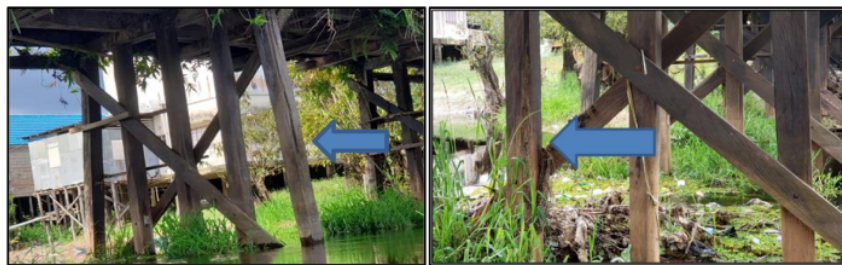
Figure 5. Tampa Bridge Condition during Investigation

Investigation on Tampa Bridge is based on field observations of the existing condition of the bridge. Area to be investigation are channels and water directions including riverbanks, embankments, and flood inundation areas, then the bottom of the bridge includes piers, fittings and sloop (Gal & Kryvoruk, 2010). For superstructure part includes the girders and floors, the results of investigation, the average importance the average service importance the results are presented in Table 2 and shown in Figure 5 and 6.

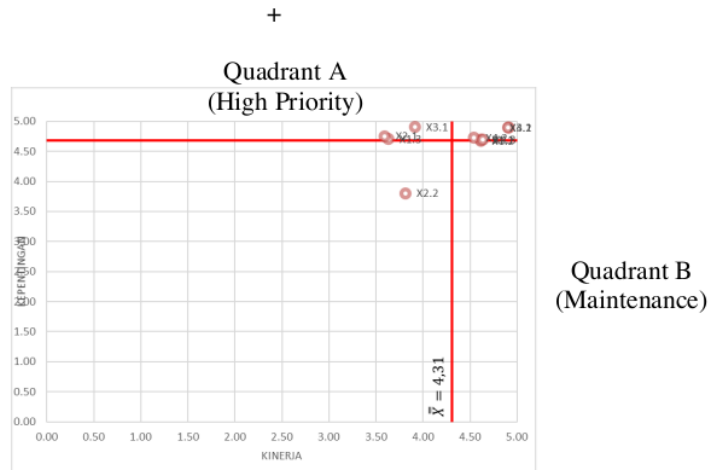
The summary of the investigation result shown in Figure 6, that the position of the data result in quadrant A means high priority to handle and some parts are in quadrant B means maintenance the existing those support better performance for the bridge itself and the user of the bridge.

Figure 6. Quadrant Summary Analysis of Bridge Performance and Users Satisfaction
