ANALYSIS OF THE HABITABILITY OF PELAMBUAN RESIDENTIAL AREA, WEST BANJARMASIN

Erika Zeannyta*, Aqli Mursadin

Faculty of Engineering, Lambung Mangkurat University Banjarmasin, South Borneo, Indonesia,
erika.zeannyta@gmail.com, a.mursadin@ulm.ac.id

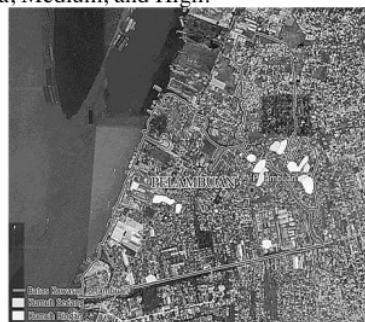
area not being fully utilized by investors due to a lack of promotion and information about the potency area. Figure 1 shows the Pelambuan area with distribution locations slum settlements with Low criteria, Medium, and High.

Figure 1. Map of Pelambuan residential area, West Banjarmasin (Identification of Slums in the 2015 Mayor's Decree)

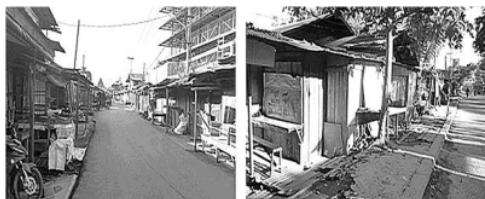
These problems are the background behind analyzing the habitability of both the building and the residential environment. This case does for know the condition of residential buildings and the environment in terms of feasibility and quality. Pelambuan residential area will be analyzed based on three physical aspects: building, environmental, and legality. Building aspects review construction used, the physical condition of the building, lighting in buildings, indoor ventilation buildings, and building health includes the spatial condition of the intended building to analyze the habitability of the building housing in settlements in the Village ambush. Build quality housing formed affects the environment surrounding settlements, where the quality bad residential buildings affect the appearance of the settlement environment formed. The view of residential buildings seen on environmental display can be seen in Figure 2.

Figure 2. Settlements in Pelambuan (Personal documentation)

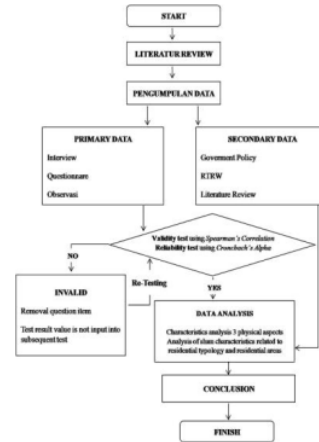
All research activities will be described in Figure 3, which is a flow chart research.

Figure 3. Flowchart research (Personal analysis, 2020)
