Analysis of Condenser N-16000-2 Unit I PLTU I Central Kalimantan (2x60) MW

Abdul Ghofur[✉], Faisal Arifin, Rachmat Subagyo, Aqli Mursadin, Ahmad Syarief, and Apip Amrullah

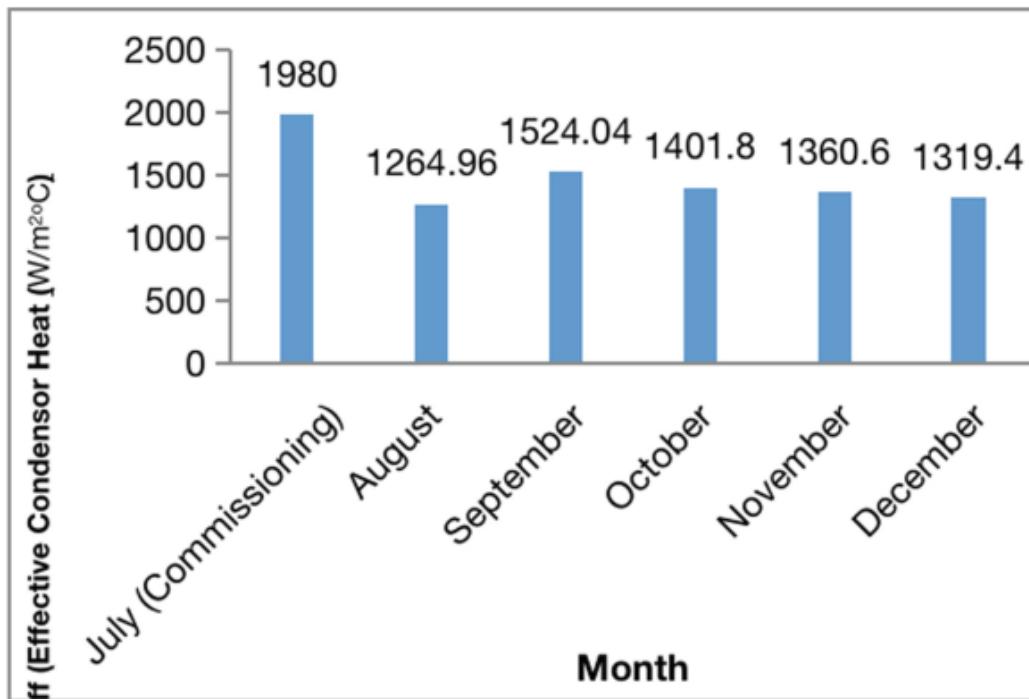
**Fig. 2.** Time Relationship Diagram to Ueff

Based on the results of the calculation of the work of the condenser unit 1 can be known the value of Ueff at the time of commissioning in July, compared to the results of calculations in August–December 2018. Results are displayed in Table 4 and Fig. 2.

From Fig. 3 it is known that the Ueff value of the unit 1 condenser when commissioning (July) is 1980 W/m^2 °C while at the time of August it is worth 1624.96 W/m^2 °C so that the difference is 355,037 W/m^2 °C. The difference indicates a considerable decrease in performance even though the new unit is operating for about 1 month. Then the commissioning conditions compared to March. In September Ueff condenser was worth 1524.04 W/m^2 °C, meaning a decrease in employment by a margin of 455. W/m^2 °C. Then the commissioning conditions were compared to October. In October Ueff condenser was worth 1401.80 W/m^2 °C, meaning a decrease in employment by a margin of 578.2 W/m^2 °C. Then the commissioning conditions were compared to November. In November Ueff condenser was worth 1360.60 W/m^2 °C, meaning a decrease in the performance by a margin of 619.4 W/m^2 °C. Then the commissioning conditions were compared to December. In December Ueff condenser is worth 1319.40 W/m^2 °C, meaning a decrease in performance by a difference of 660.6 W/m^2 °C. In each month there is always a decrease and the difference is greater when compared to Ueff when commissioning conditions.

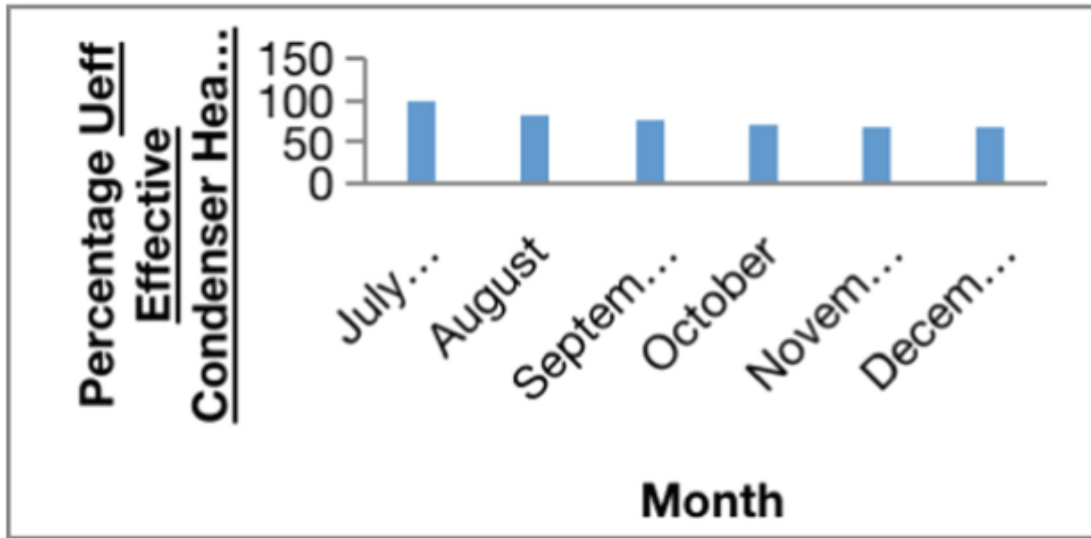
Fig. 3. Time Relationship Bar Chart Against Value Percentage Ueff Decline

With the data obtained in Table 4, it was also obtained the value of the presentation of Ueff's decline in commissioning results compared to August-December. Results are displayed in Fig. 3.

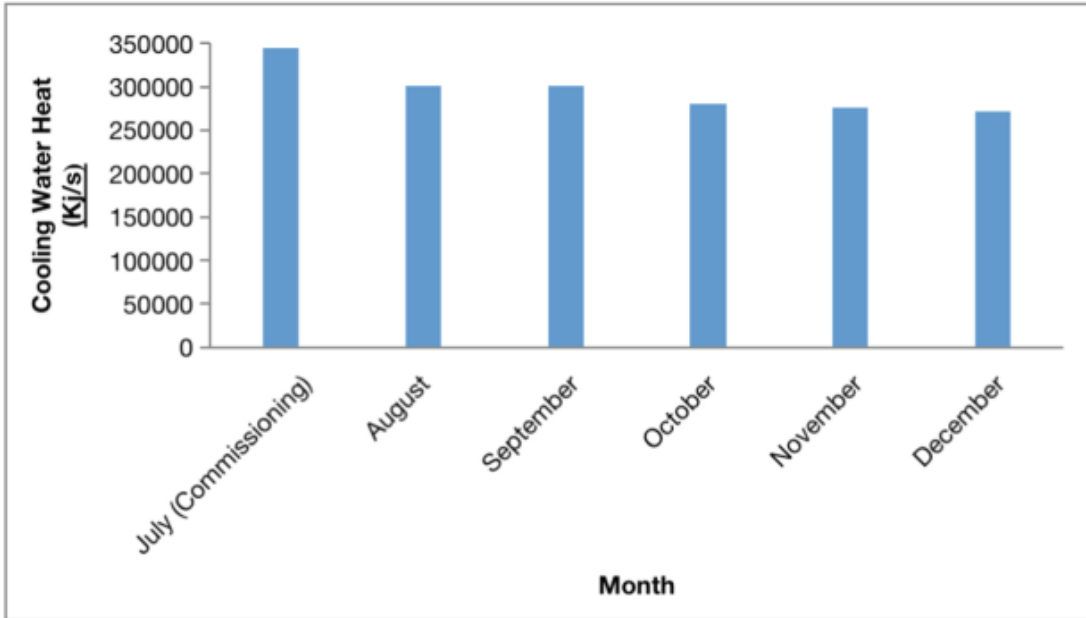
Fig. 4. Time Relationship Diagram to Heat Cooling Water

The main cause of the decline in Ueff value is the smaller the heat value of cooling water. From commissioning conditions to actual data collection in August - December 2018 continues to decline. The main cause of the decrease in cooling water heat is

the continued decrease in the enthalpy differential between the outgoing cooling water enthalpy and the cooling water enthalpy in. The decrease in the heat value of the cooler can be seen in Fig. 4.

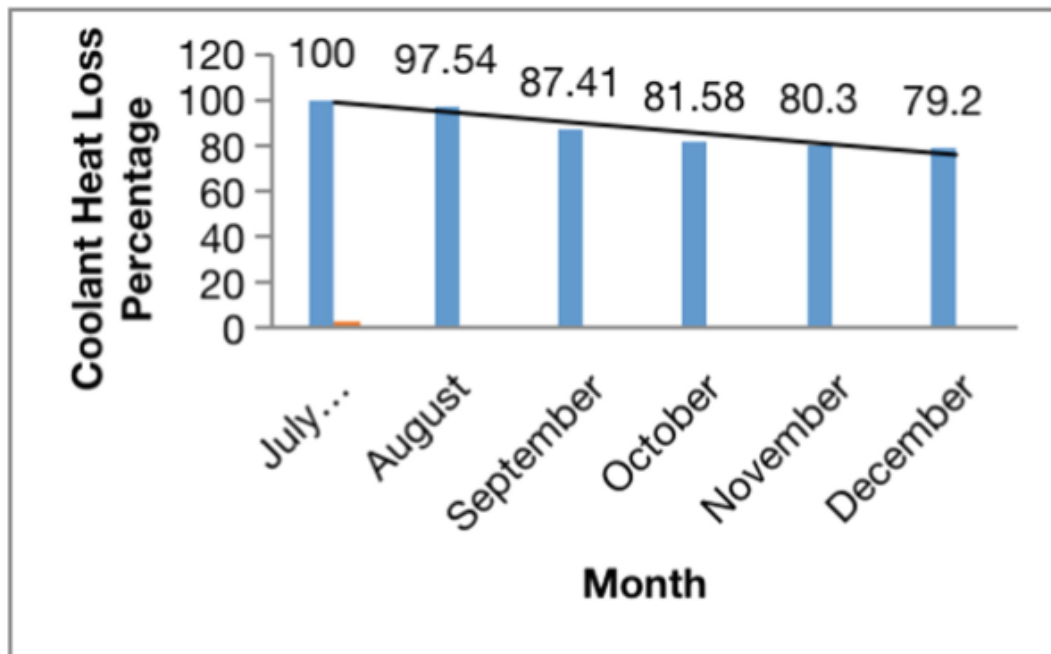
Fig. 5. Time Relationship Diagram to Decrease Percentage Heat Cooling Water

With the data obtained in Table 4, the value of the decrease in the presentation of cooling heat from commissioning results compared to August-December was obtained. Results are displayed in Fig. 5.

It can be seen in Fig. 6 where in August the value of Heat water cooler condenser unit I PLTU 1 Kalimantan decreased the heat value of cooling water by 2.46% compared to the time of commissioning. In September, the heat value of cooling water decreased by 10.13% compared to August. In October there was a decrease in the heat value of cooling water by 5.83% compared to September. In November, the heat value of cooling water decreased by 1.28% compared to October. In December there was a decrease in the heat value of cooling water by 1.1% compared to November. In the graph above if the trendline formula is entered where y becomes 50% then obtained x = 11.6 where in June 2019. The condenser of unit I PLTU I Kalimantan requires a complete overhaul.

To avoid a decrease in the performance of the condenser unit I PLTU I Central Kalimantan which is too high, it is necessary to make an IK (Work Instruction) based on the value of the condenser's own performance value. The data is displayed in Table 5.
