# **CASE STUDY OF THE CAUSES OF FAILURE OF COMBINATION OF GABION AND GEOTEXTILE CONSTRUCTION TO HANDLE LANDSLIDES ON THE SLOPE OF KARIANGAU SUBSTATION, BALIKPAPAN, EAST BORNEO**

Desy Rahmadania dan Rusdiansyah

*Civil Engineering Department, Faculty of Engineering, University of Lambung Mangkurat*

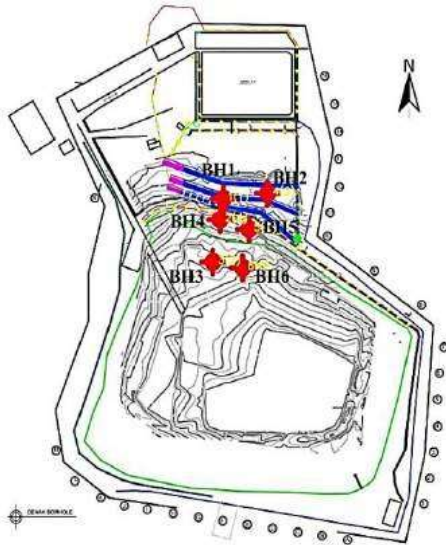
Figure 4. 1 Sampling Location Point Stage 1

In the initial soil investigation, drilling was carried out at 6 different points as shown in Figure 4.1.

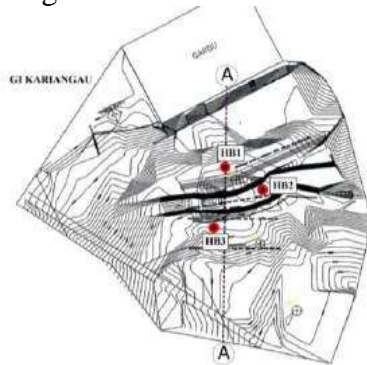
Figure 4. 2 Locations for Stage 2 Sampling.

In the second phase of the soil investigation, drilling was carried out at 3 different points as shown in Figure 4.2.

- c) At HB-3 (Level 3) the value of  $q_u$  is  $0.201 \text{ kg/cm}^2$  which includes soil with a very soft consistency, which means this soil has a low infiltration rate and poor drainage properties.

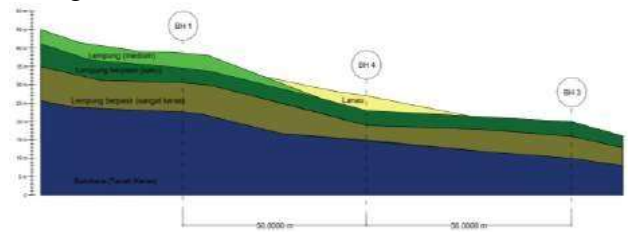
Figure 4.3 Statigraphy of Soil Layers

Based on the results of the interpretation of the soil investigation data, a soil layer stratigraphy can be made. In making soil layer stratigraphy, interpretation data is used on BH1, BH4, and BH3 with a distance between points of borehole 50 m and 56 m, so that the

soil layers that make up the slopes can be seen in Figure 4.3.

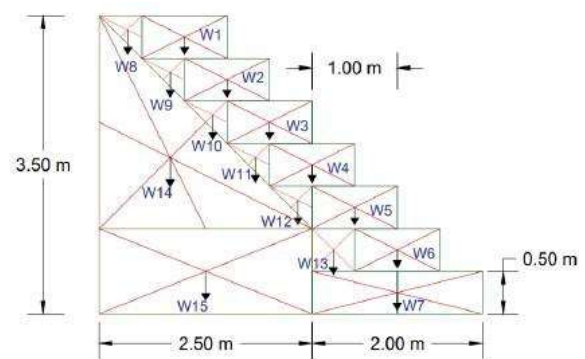
Figure 4.4 Gabion Dimensions Level 1 Distribution

In the above calculation, the results of the active earth pressure are negative. According to Hardiyatmo (2011) this shows the existence of a tensile force acting on the soil. As a result, the part of the soil that experiences tension becomes cracked. These cracks if filled with rainwater, can reduce the value of soil cohesion.

Level	Stability	SF	Safe Conditions	Ket.
1.	Rolling Stability	14,511	2	Safe
	Shear Stability	9,952	2	Safe
	bearing capacity	$q_{all} = 50,314 \text{ kN/m}^2$	$q_n = 175 \text{ kN/m}^2$	Safe

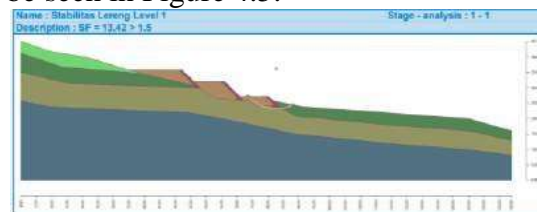
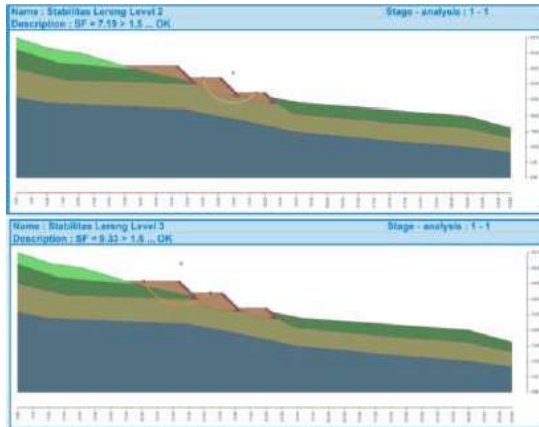
Figure 4.5 Value of Slope Safety Factor with Gabion Reinforcement at Each Level

The value of the safety factor against landslides for slopes level 1,2 and 3 based on the results of the Geo5 program analysis can be seen in Figure 4.5.

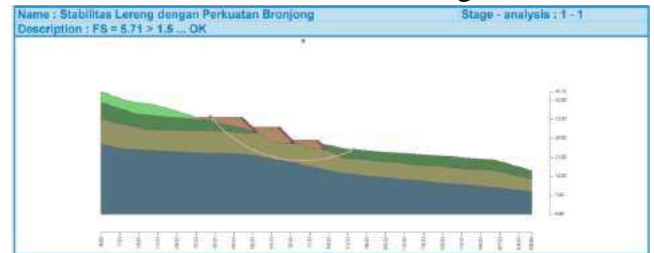
Figure 4.7 Results of Slope Stability Analysis with Gabion Reinforcement.

After obtaining the value of the safety factor on the slope without reinforcement, then an analysis is carried out on the slope with only the reinforcement of gabions. This is done to determine the effect of gabion reinforcement on the slope safety factor in landslides, which can be seen in Figure 4.7.

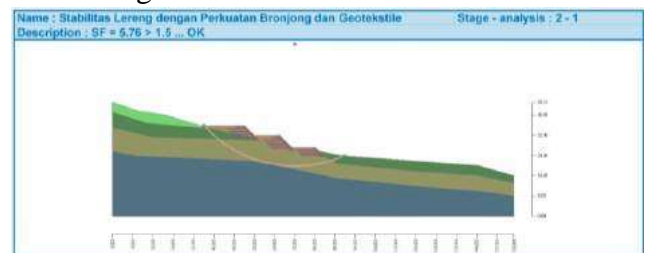
Figure 4.8 Results of Slope Stability Analysis with Geotextile Reinforcement.

Next, an analysis of the slopes with additional geotextile reinforcement was carried out as in field conditions. This is done to determine the role of geotextiles on the value of the slope safety factor, which can be seen in Figure 4.8.

Based on analysis of the safety factor of slope stability using Geo5 program in 2020 obtained the value of the safety factor meet the minimum requirements of 1.5. However, this is not in accordance with the conditions that occur in the field, where there is a failure in the construction of a combination of gabions and geotextiles.

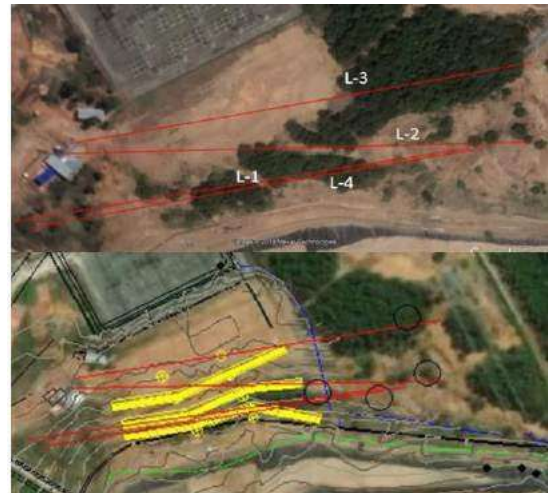
Figure 4. 16 Geoelectrical Trajectory Plan

This geoelectric measurement was carried out by PT. Bangun Prima Semesta with 2-dimensional measurements. It should be noted that this measurement is carried out during the rainy season, with the advantage of being able to clearly see the difference between zones that are saturated with water and those that are not. The location of data collection used as many as 4 paths, can be seen in Figure 4.16. With point 0 for each

track starting from the east side and the distance between the electrodes is 5 m.
