Analysis Of Water Status Quality And Flood And Innundation

Analysis Of Water Status Quality And Flood And Innundation Causes In Rawa Matang Hanau Irrigation Area Balangan District

Chandra Wahyu Sulisty "Analysis Of Water Status Quality And Flood And Inundation Causes In Rawa Matang Hanau Irrigation Area Balangan District "IOSR Journal of Mechanical and Civil Engineering (IOSR-JMCE) , vol. 15, no. 5, 2018, pp. 65-73

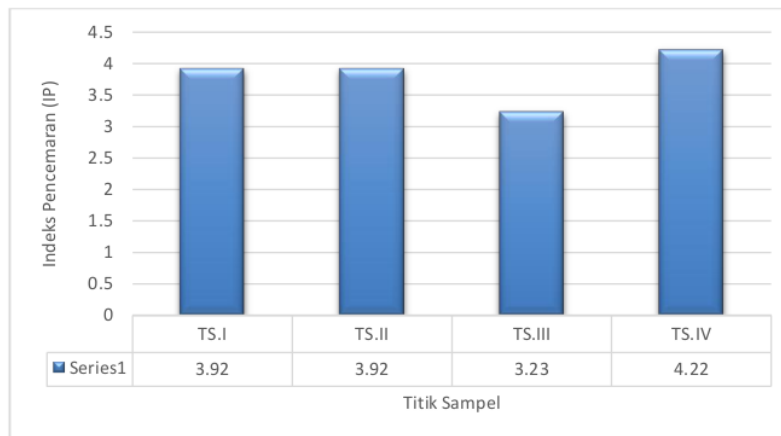
Figure 1. Results of Pollution Index Analysis on Quality Standards I

The analysis indicates that all IP values for all sample points against quality standards are in the range of $1.0 < PI_j \leq 5.0$ which identifies that the water condition in the channel is lightly polluted against the quality standard I as the designation of raw water clean water.

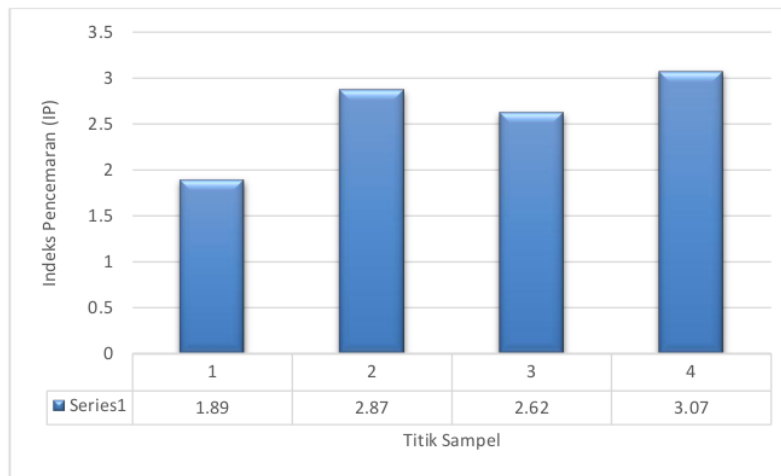
Figure 2. Results of Pollution Index Analysis on Quality Standards II

The analysis indicates that all IP values for all sample points against the quality standard are in the range of $1.0 < PI_j \leq 5.0$ which identifies that the condition of the water in the channel is lightly polluted against the quality standard II as water designated for agricultural and plantation purposes.

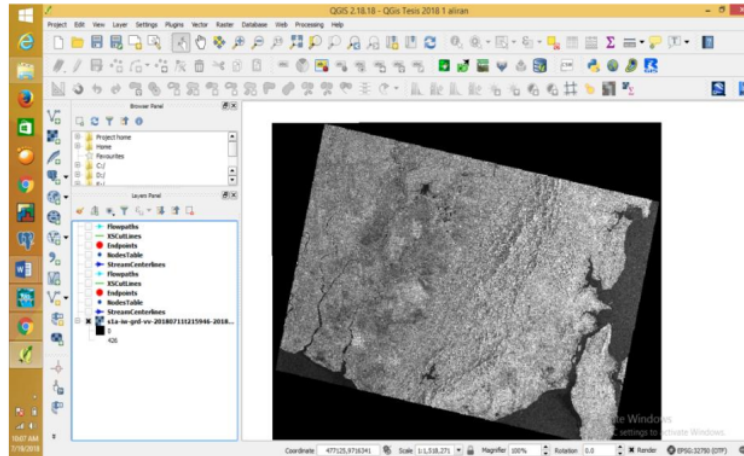
Figure1. DEM Layer (Source: Analysis)

Evaluation of the existing channel begins with the imitation of channel geometry using the Qgis 2.18.18 application and using model elevation data (DEM) obtained from <https://scihub.copernicus.eu>. Imitation of channel geometry in gis application is supported by rivergis application. The results of geometry imitation can be seen in Figures 3 and 4.

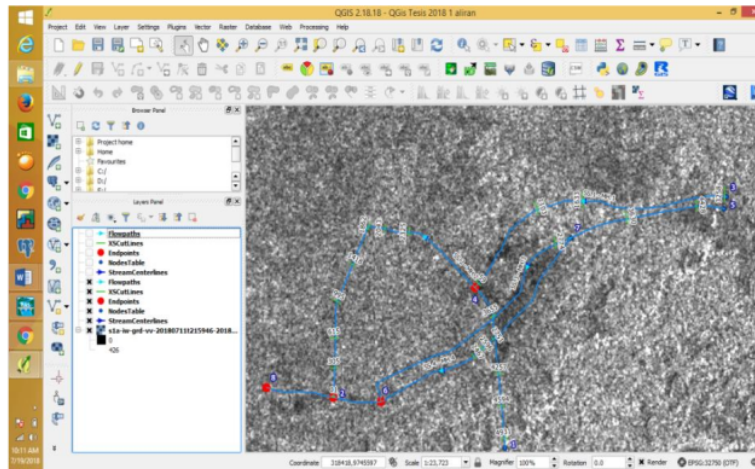
Figure 4. Results of Channel Geometry Imitation (Source: Analysis)

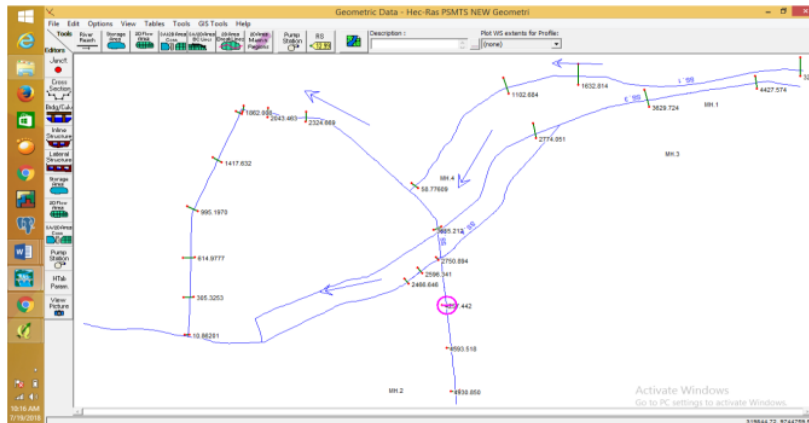
Figure 5. Channel Geometry Results Imported from Qgis (Source: Analysis)

After the channel geometry imitation is complete, the channel geometry is converted to a hec-race file using the RiverGis plugin. The geometry of the converted channel is imported into hec-race as the channel geometry for the hydraulic analysis process, as shown in figure 4.6.

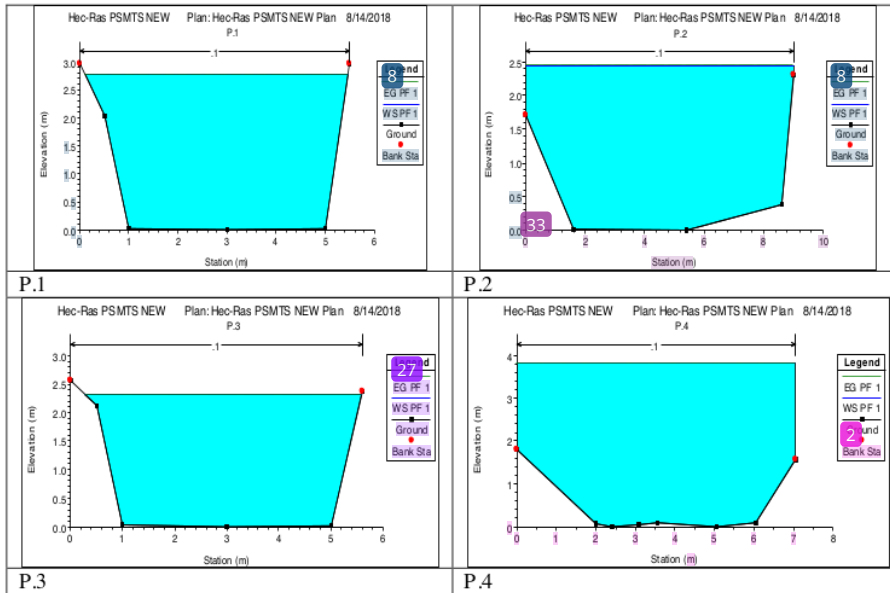
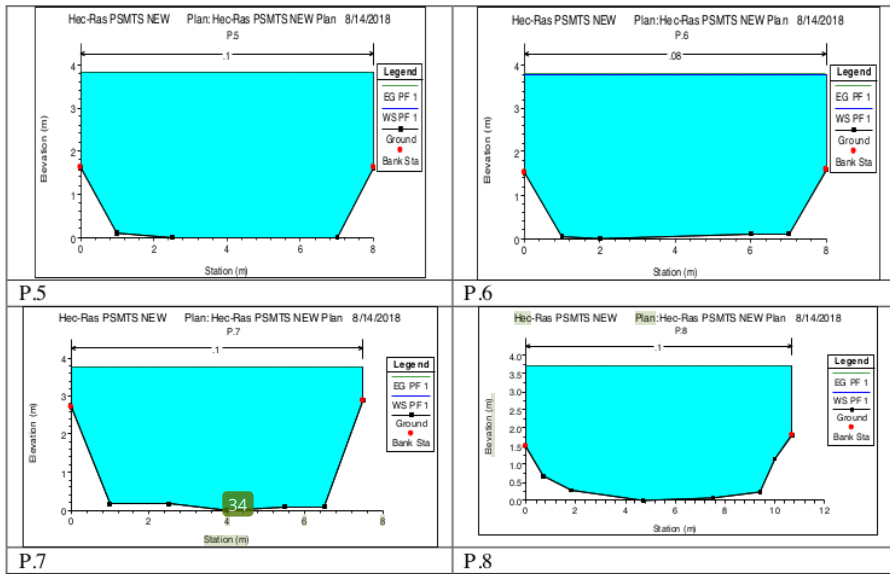
Figure 6. Results of Hec-Race Simulation of Debit Plans Q1

Hec-Ras simulation was used to predict the condition of the channel section and water level in the existing channel using the smallest discharge. Different roughness values for each channel were reviewed. Roughness values for SS.1, SS.2 and SS. 4 were the flow of grass, deep grooves, or flood paths with trees and shrubs (Very weedy reaches, deep pools, or floodways with heavy stands of timber and brush) in accordance with table II.9 with roughness value of 0.1. Roughness value for SS.3 channel takes form of clean and straight flow, full water level, no gap or deep part (kedung) (clean, straight, full, no rifts or deep pools) with value of 0.030. The results of the existing channel simulation on the smallest plan flood debit are can be seen in Figure 6.

Based on results of the hec-race application simulation with a 2-years return period, all channel sections are unable to accommodate the flood debit, so that a rise in water level exceeds the height of the channel section where it causes flooding in the Matang Hanau swamp irrigation area. Based on the analysis results, it is necessary to redesign the cross section of the channel with a 10-years flood debit.

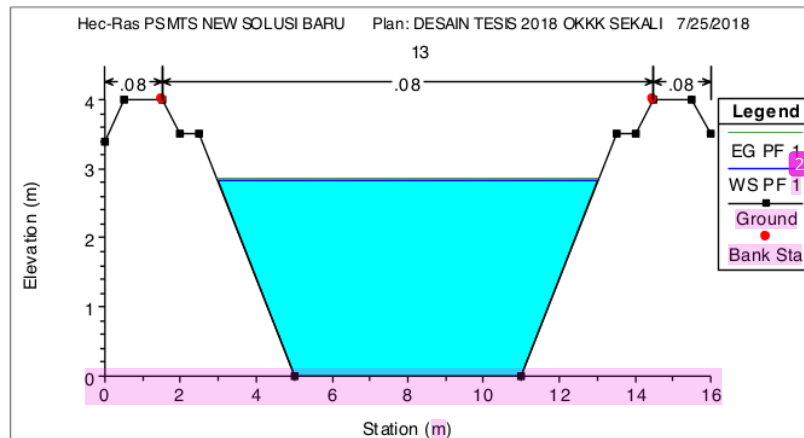
Figure 7. Cross Section Simulation P.1 SS.1-MH.1 (Source: Analysis)

Based on the design calculation, the channel dimension can accommodate the flood debit plan. Based on the data - design data of channel dimensions and flood debit plan, the simulation was taken with Hec-race application. Simulation results can be seen in the following figure:

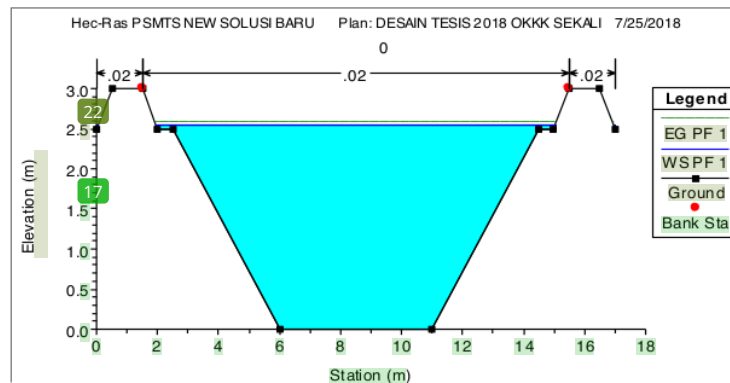
Figure 8. CrossSection Section P.5 SS.2-MH.2 (Source: Analysis)

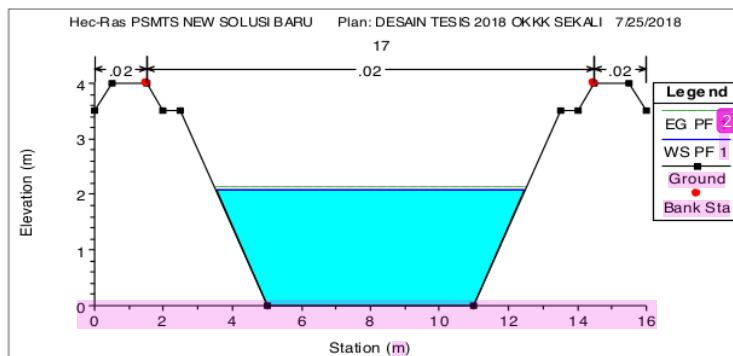
Figure 9. Cross Section Simulation P.18 SS.3-MH.3 (Source: Analysis)

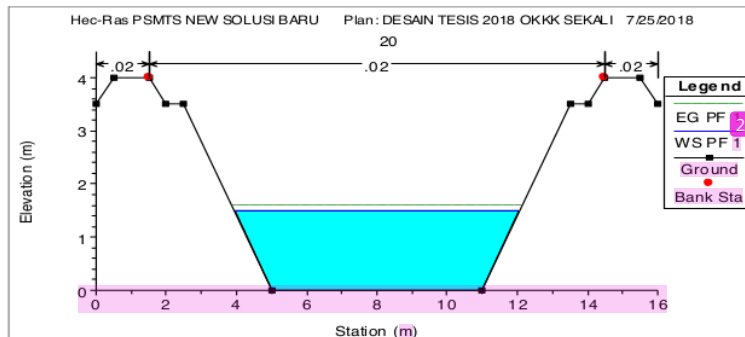
Figure 10. Simulation of Section Section P.21 SS.4-MH.4 (Source: Analysis)
