Assessment of Inland Water Quality In Banjar Regency Using Remotely Sensed Satellite Image

Rony Riduan, Riza Miftahul Khair, Andre Anantama Irawan, and Farrel Alta Ferisza Siregar
Environmental Engineering Department
Lambung Mangkurat University
Banjarbaru, Indonesia

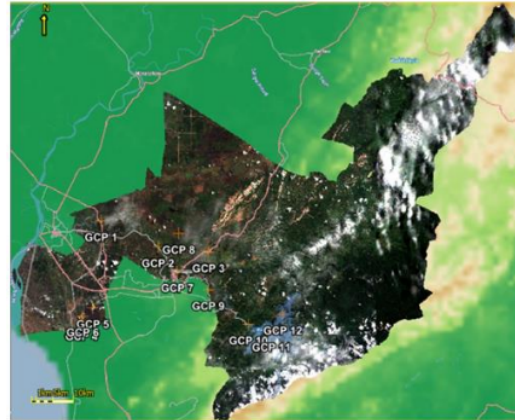
Fig 1:- Sampling Location

The location of sampling and measurement points must represent the presence of rivers, lakes, and swamps in the Banjar Regency area. The location of sampling and measurement points in GCP (Ground Control Points) can be seen in Fig. 1.

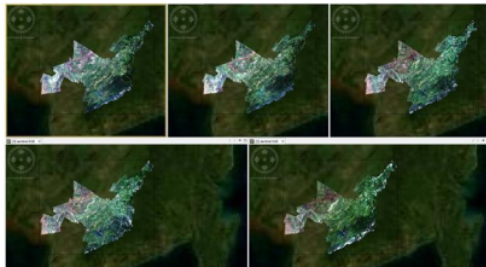
Fig 2:- RGB image from SNAP

The satellite image is taken from the Sentinel-2 satellite data with the help of the Google Earth Engine script. The image obtained through this script then goes through the stages of converting the coordinate reference system to UTM coordinates (WGS84/UTM Zone 50S). The image is also resampled to a resolution of 10 m. The images obtained are satellite images for Bands 1 to 12 which are averaged per year of observation. The image obtained is still divided into several images, so it must undergo a merging process. The merging process is carried out with the SNAP application through mosaicking. The combined satellite images are then processed and displayed in the SNAP application (Fig. 2). Observations were made from early 2018 to mid-September 2022.

Based on the resulting image, the existing bands are then processed to obtain the values of NDWI (Normalized Difference Water Index), NDTI (Normalized Difference Turbidity Index), Turbidity, TSS (Total Suspended Solid), CDOM (Coloured Dissolved Organic Matter), and Chl-a (Chlorophyll-a).
